Date : 23.03.2011 - Airjet reed serial number 20112345/2

AIRFLOW PROTOCOL

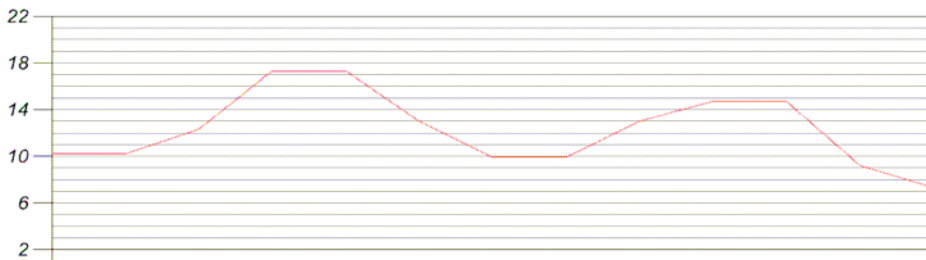
Step 1
 Received reed from customer the 22.03.2011. Reed airflow inspection before cleaning the reed to check conditions of reed efficiency .

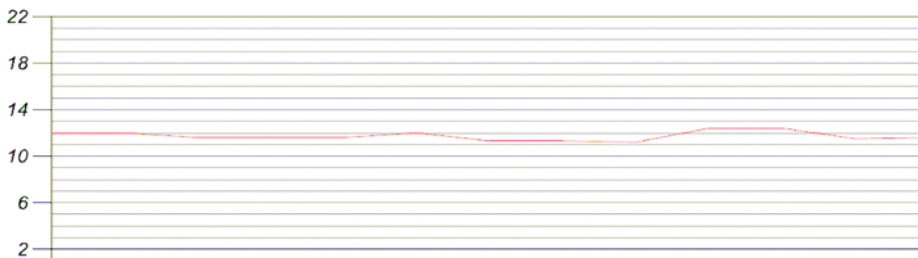
Step 2
 Reed airflow inspection after cleaning the reed by ultrasonic reed cleaning machine.

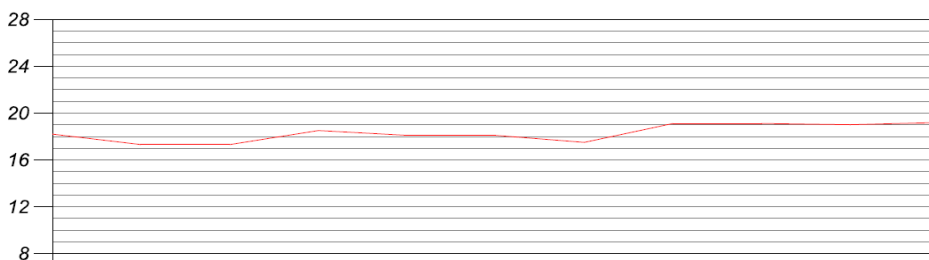
Step 3
 Reed airflow retuning according to loom type. Pressure was too low. (Step 2 +-12 Mbar) Has been corrected to ideal pressure value (Step 3 +- 18 Mbar)
